The Road Inventory of Hagerman National Fish Hatchery Hagerman, ID

Prepared By:
Federal Highway Administration
Central Federal Lands Highway Division
April 2013

Hagerman NFH - 14230 Summaries

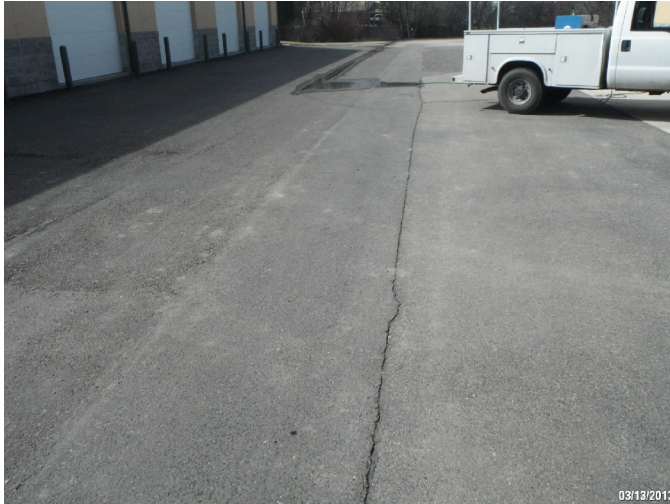
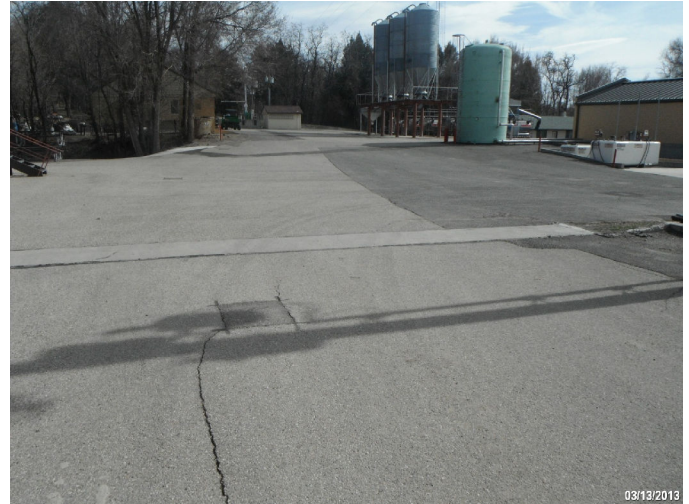
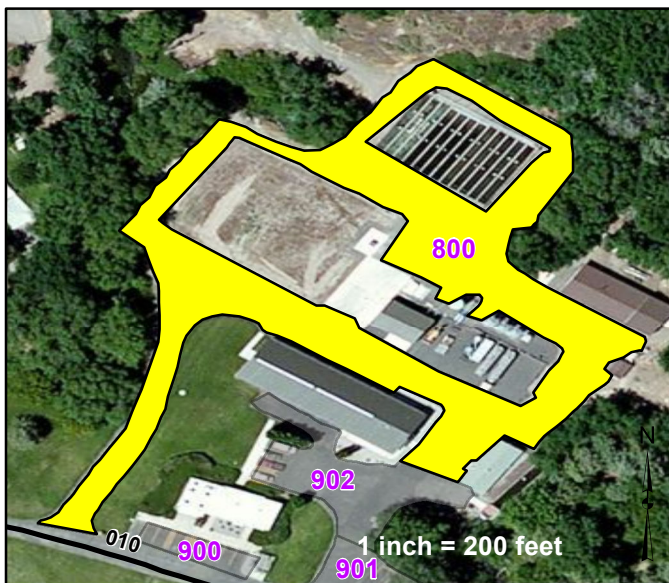
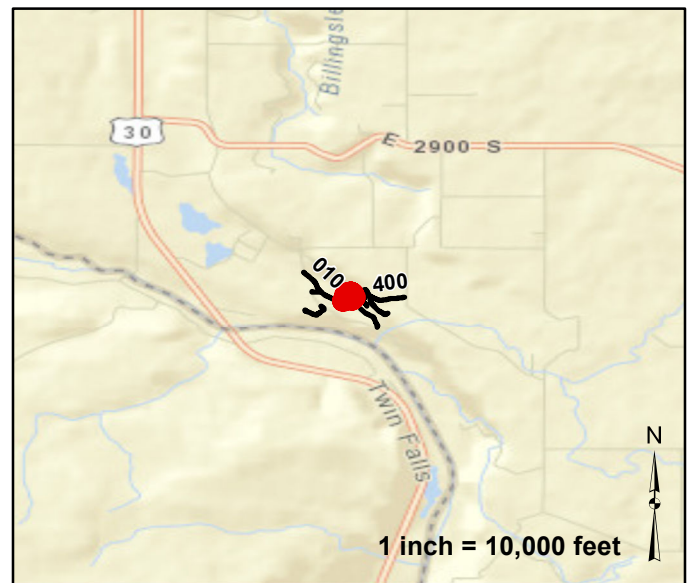
Asset Number	Area (Sq Ft)	Spaces	Condition	Surface Type	Cost to Improve	Inspection Date	Current Replacement Value
-	55491	15	Fair	Asphalt	\$43,100	03-13-2013	\$456,400

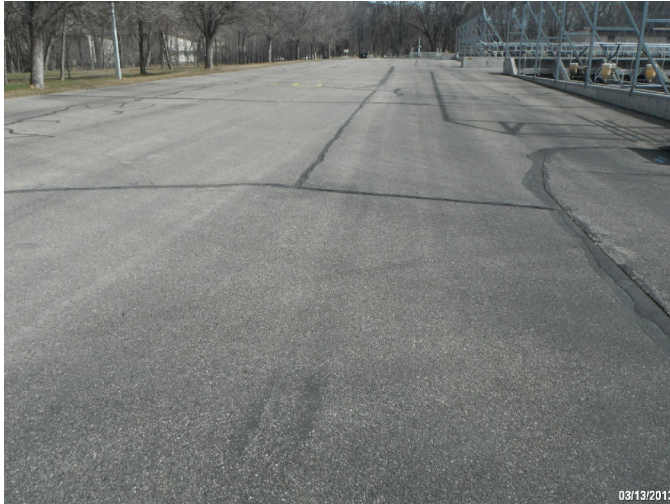
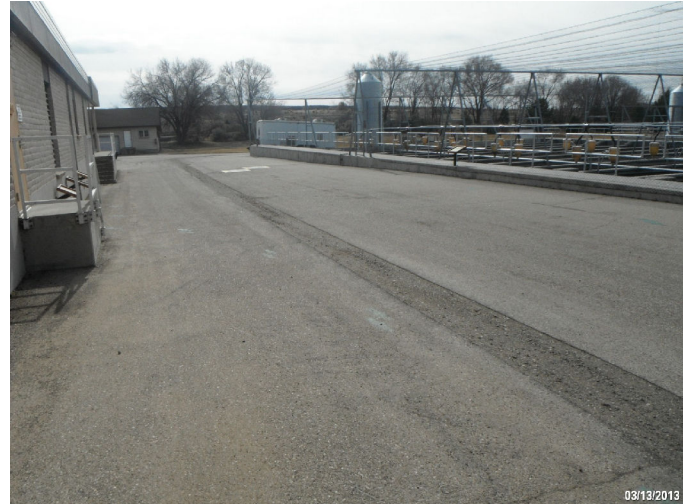
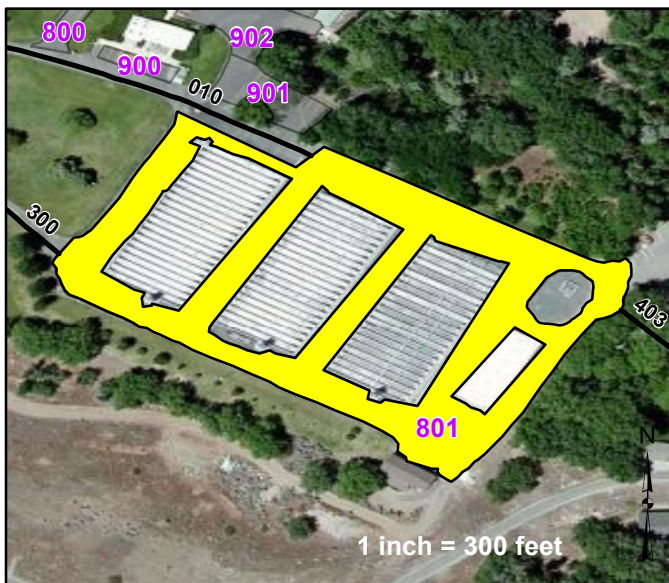
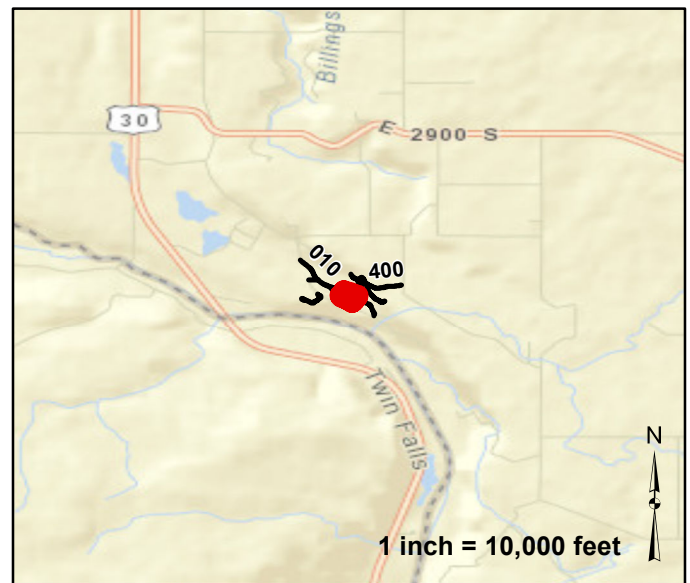
Route Number: 801

Asset Number	Area (Sq Ft)	Spaces	Condition	Surface Type	Cost to Improve	Inspection Date	Current Replacement Value
-	102823	20	Fair	Asphalt	\$79,800	03-13-2013	\$845,600

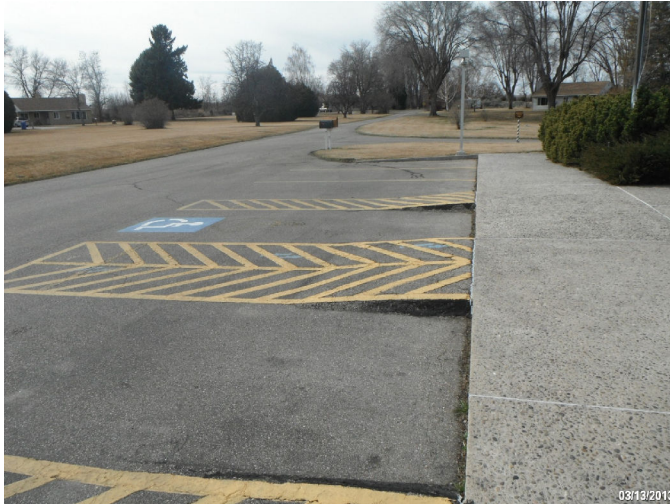
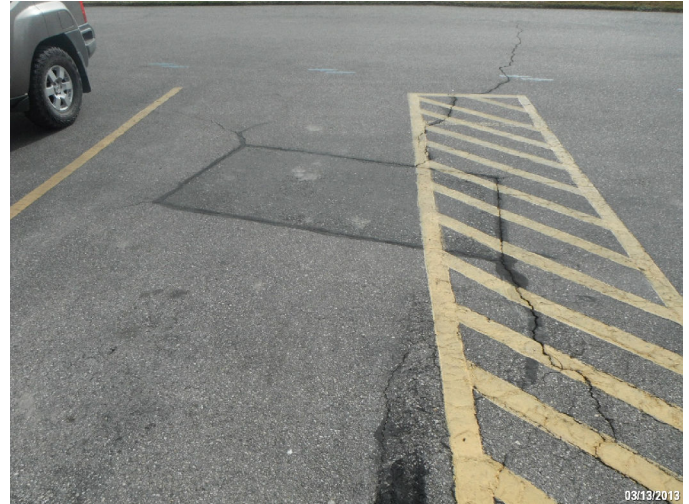
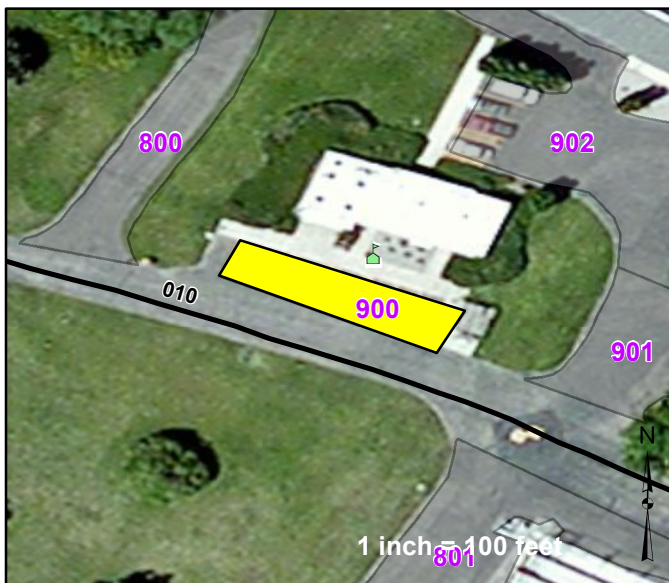
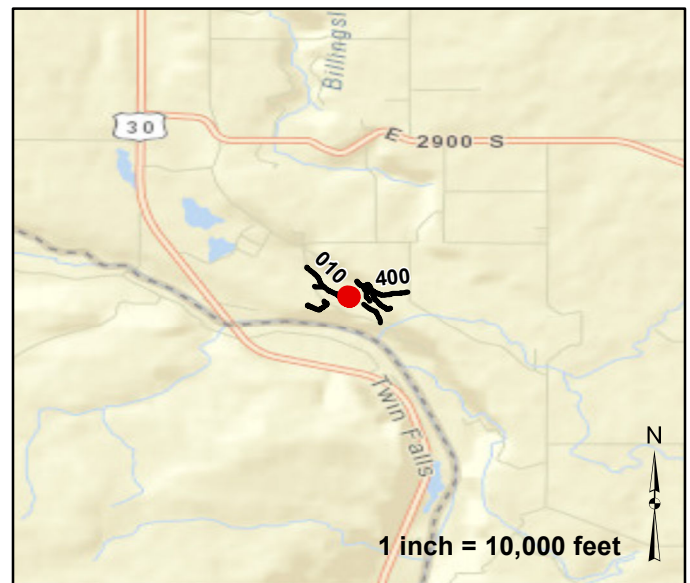
Route Number: 900

Asset Number	Area (Sq Ft)	Spaces	Condition	Surface Type	Cost to Improve	Inspection Date	Current Replacement Value
10044651	2055	8	Fair	Asphalt	\$1,600	03-13-2013	\$16,900

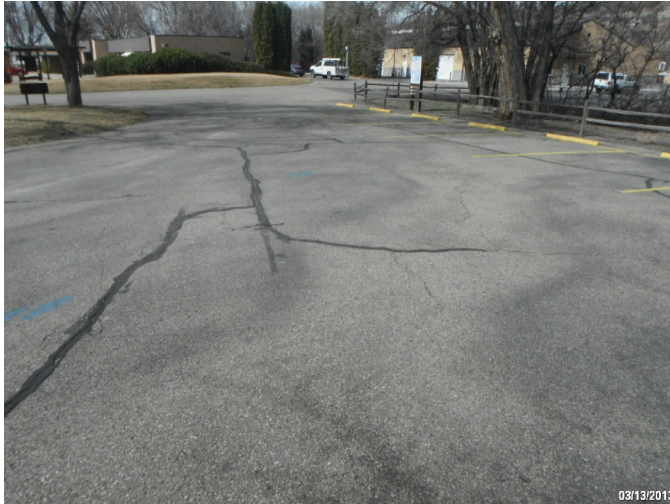
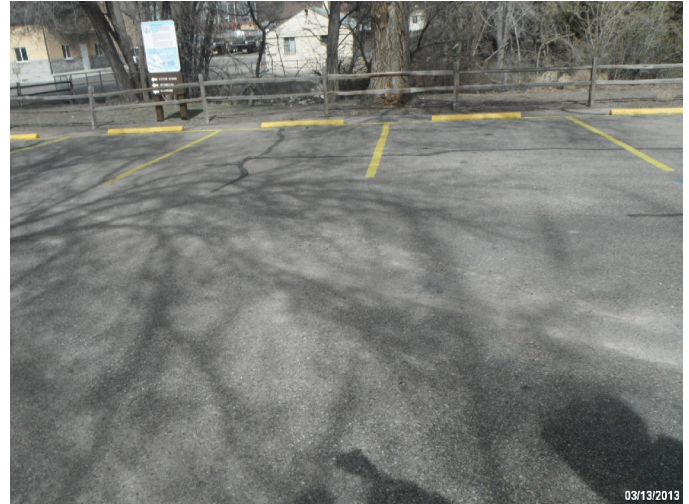
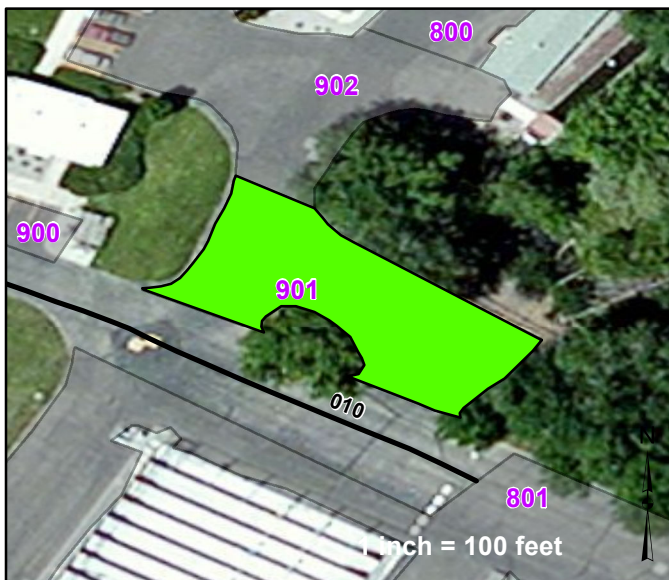
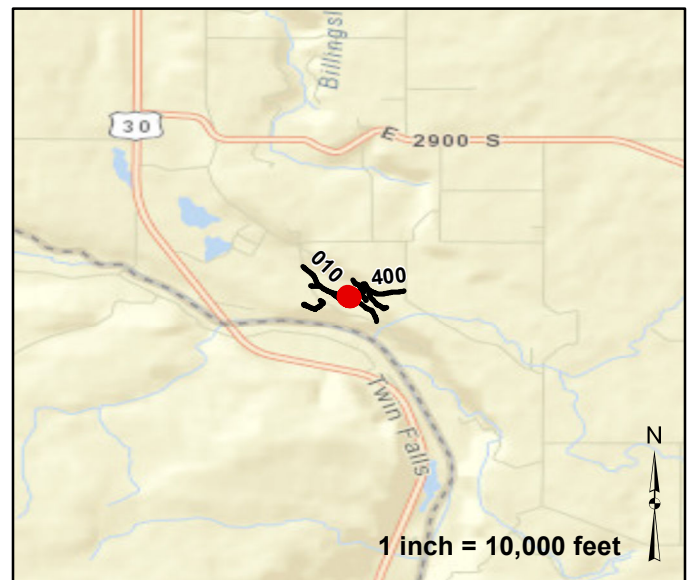
Route Number: 901
Fish Display Visitor Parking
From Hatchery Entrance Road (Route 010)

Asset Number	Area (Sq Ft)	Spaces	Condition	Surface Type	Cost to Improve	Inspection Date	Current Replacement Value
10044651	7288	6	Good	Asphalt	\$1,200	03-13-2013	\$59,900

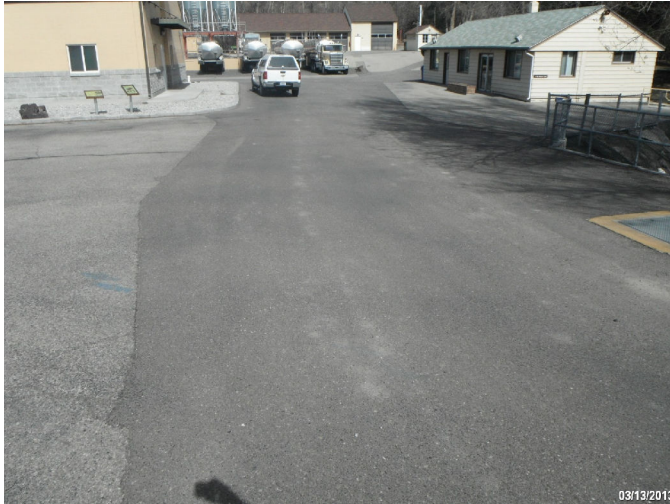
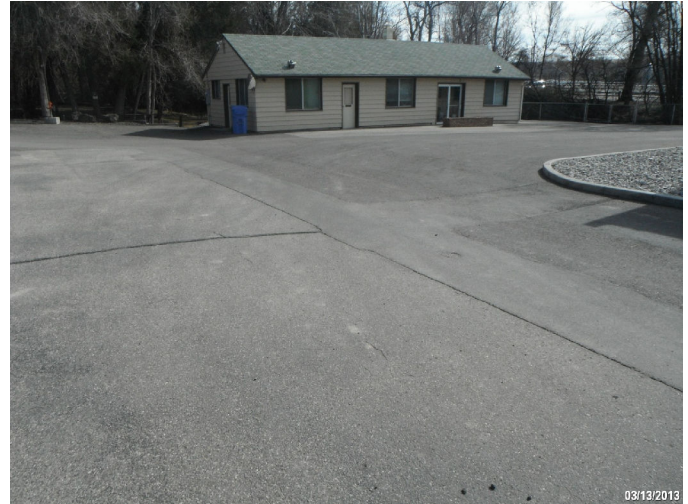
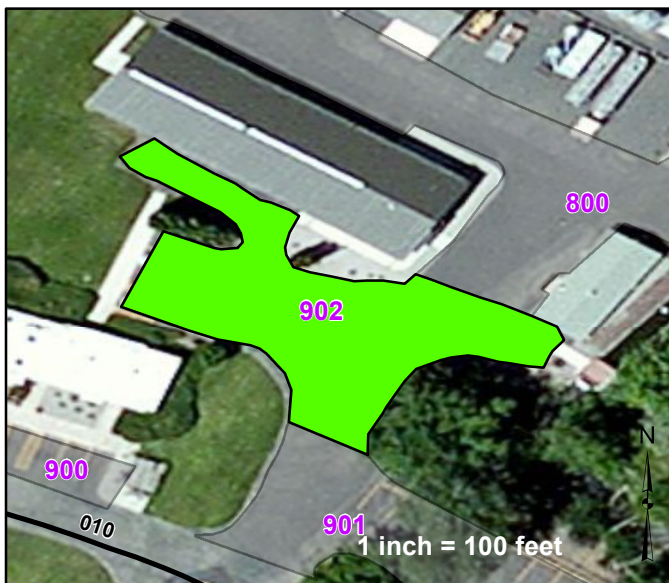
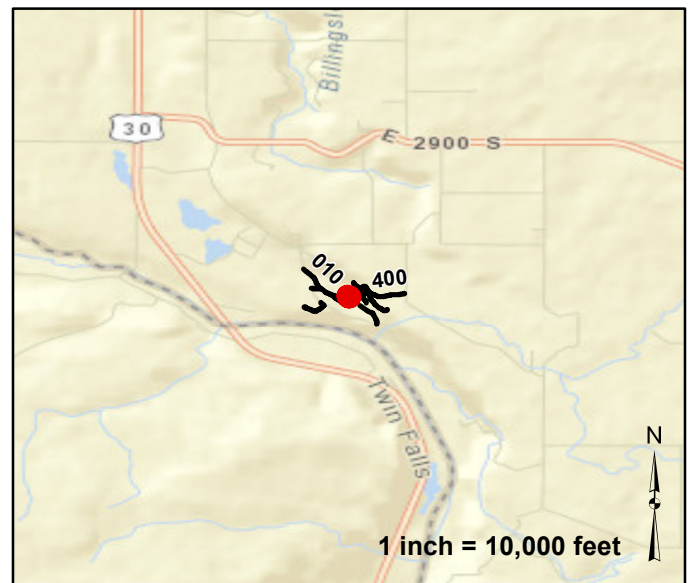
Route Number: 902 Handicapped Parking

Asset Number	Area (Sq Ft)	Spaces	Condition	Surface Type	Cost to Improve	Inspection Date	Current Replacement Value
10044651	9294	5	Good	Asphalt	\$1,600	03-13-2013	\$76,400

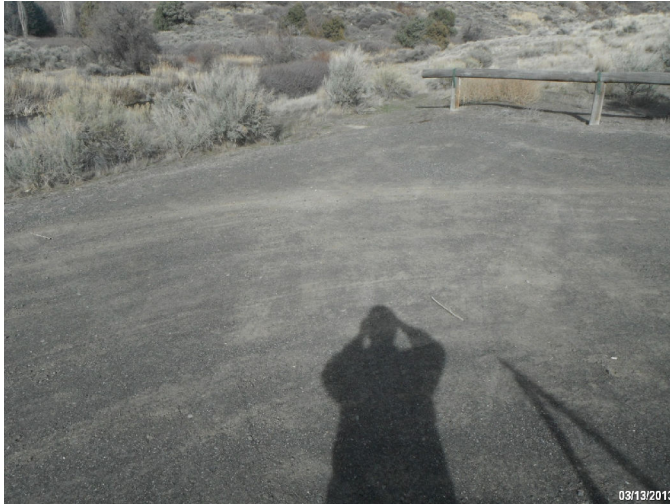
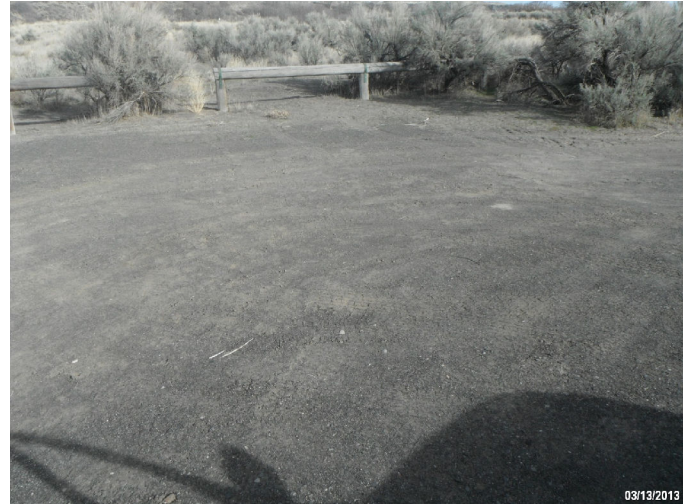
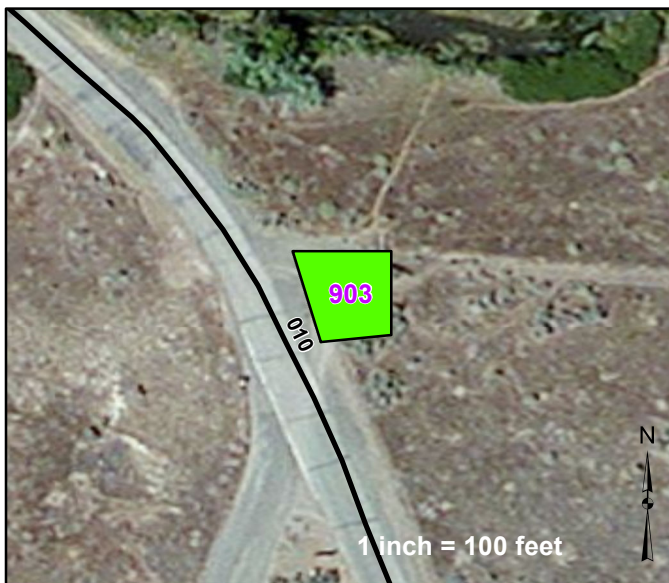
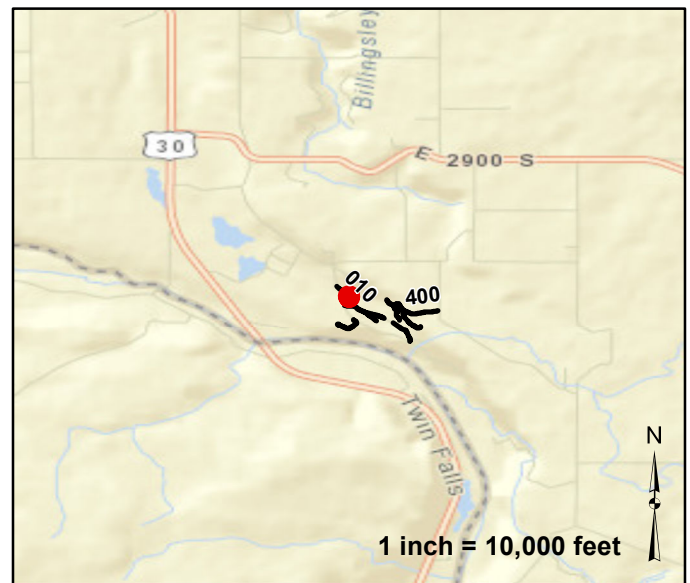
Route Number: 903

Asset Number	Area (Sq Ft)	Spaces	Condition	Surface Type	Cost to Improve	Inspection Date	Current Replacement Value
10063691	1478	6	Good	Gravel	\$200	03-13-2013	\$6,600

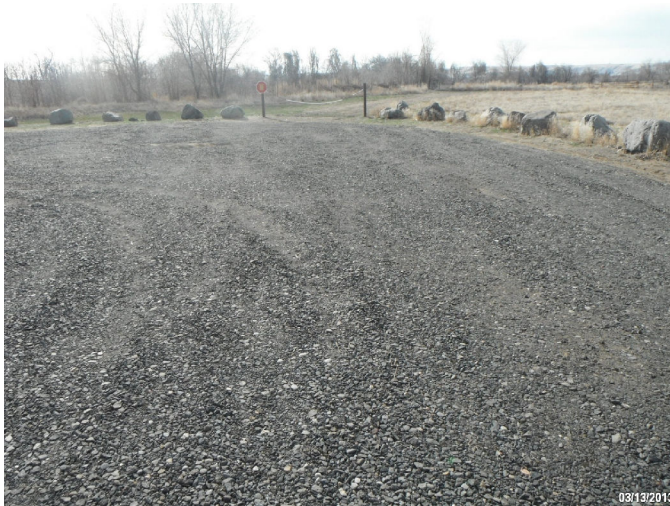
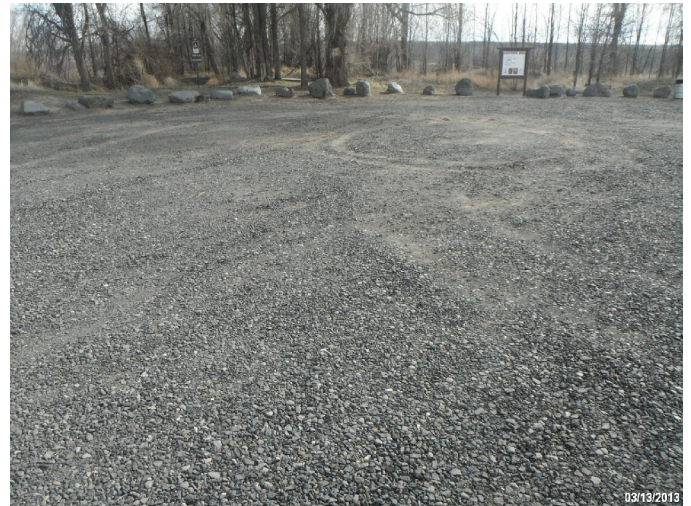
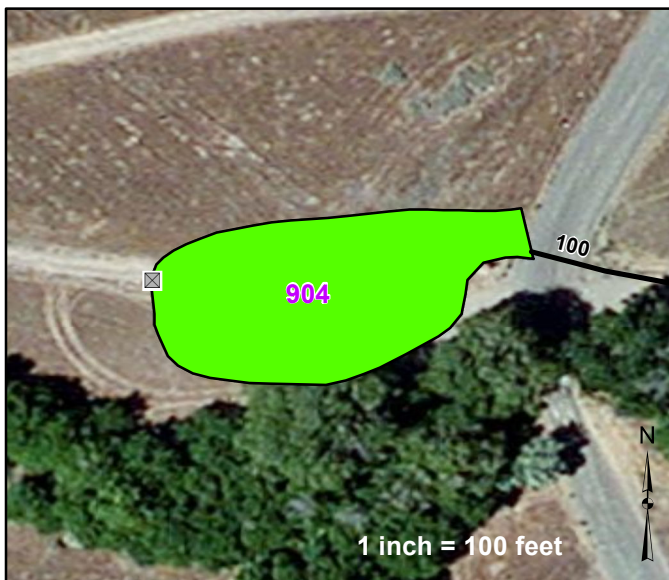
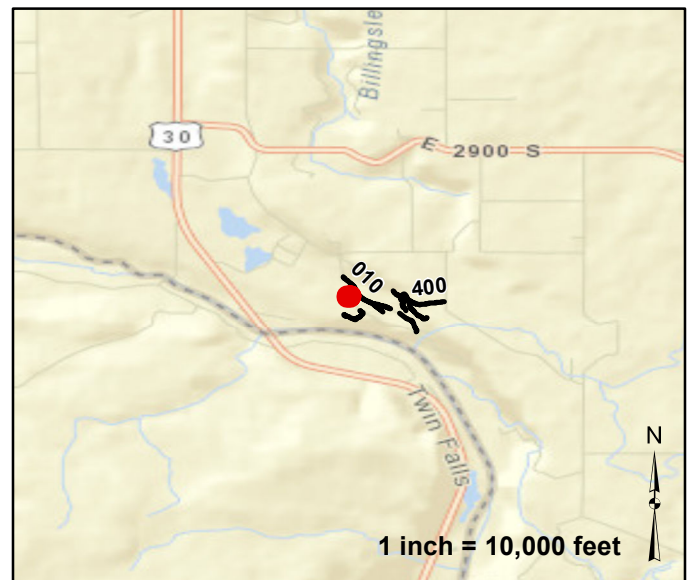
Route Number: 904
Fishing Access Parking
From Fishing Access Road (Route 100)

Asset Number	Area (Sq Ft)	Spaces	Condition	Surface Type	Cost to Improve	Inspection Date	Current Replacement Value
10063691	9629	6	Good	Gravel	\$1,300	03-13-2013	\$43,200

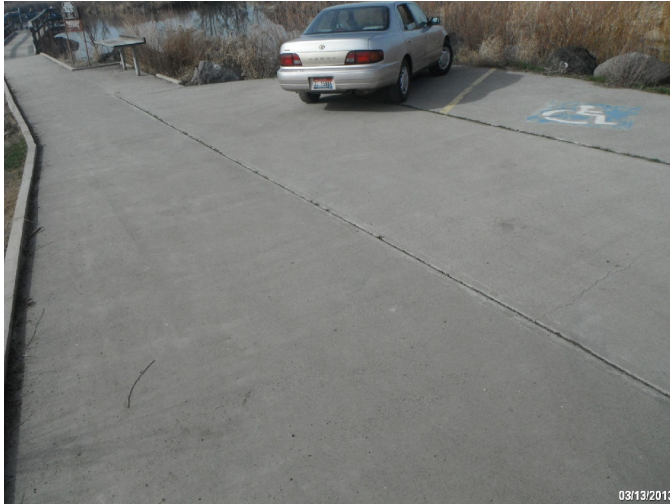
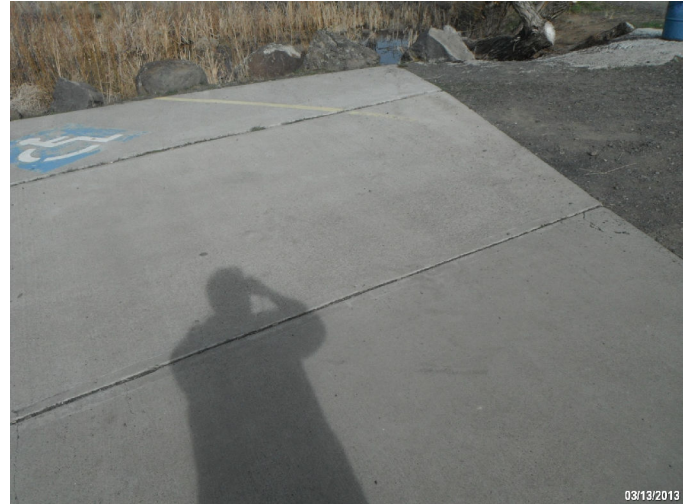
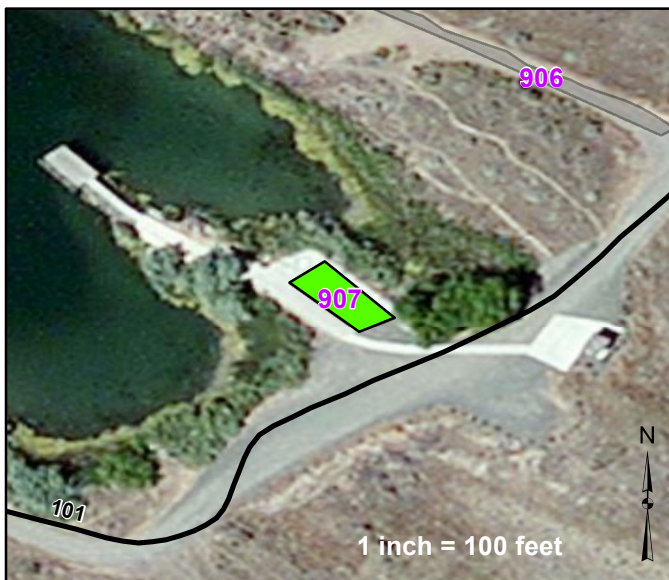
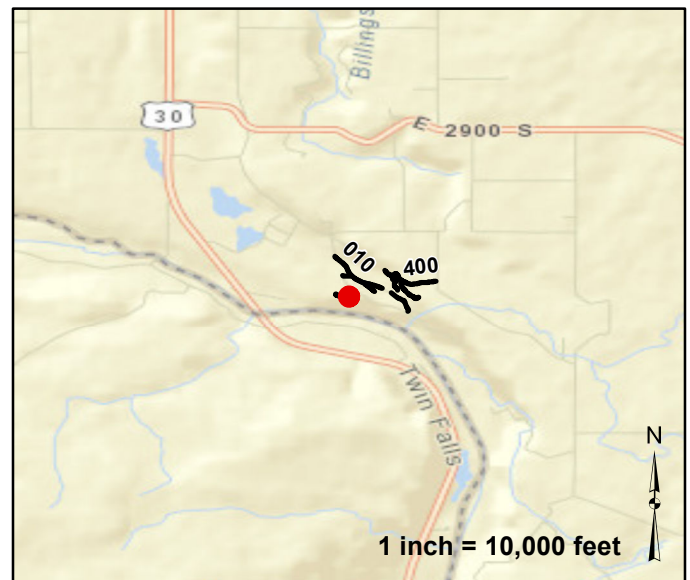
Route Number: 907
Oster Lake Handicap Parking
 From Oster Lake Road (Route 101)

Asset Number	Area (Sq Ft)	Spaces	Condition	Surface Type	Cost to Improve	Inspection Date	Current Replacement Value
10063693	612	3	Good	Concrete	\$100	03-13-2013	\$6,100

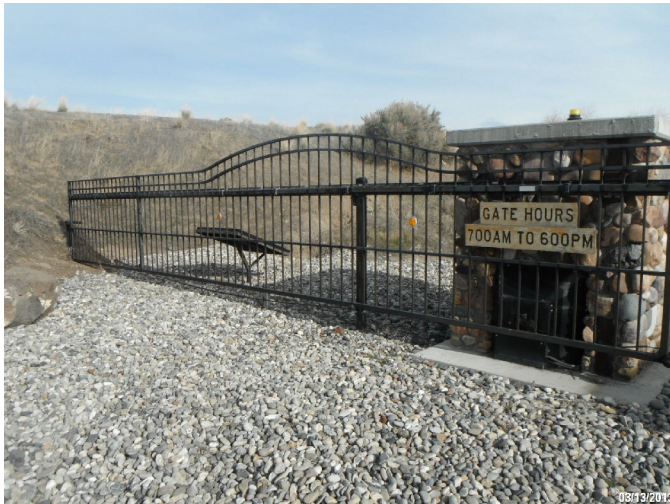
Photo: HANF_C4_0239 Route: 010-001-0.22
Metal Open Rail Gate Electric

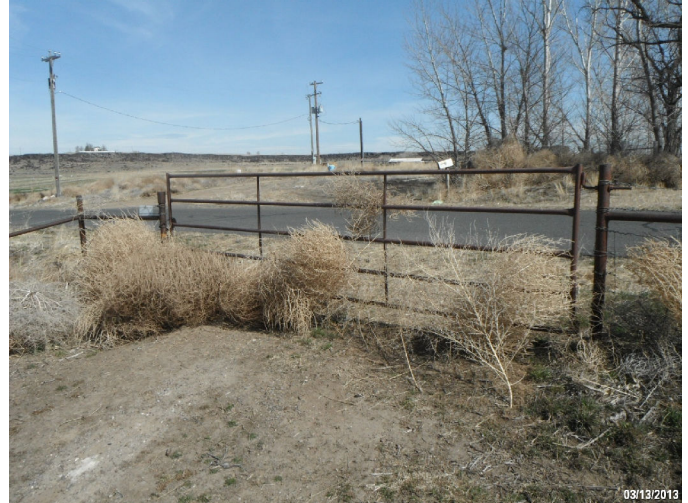
Photo: HANF_C4_0184 Route: 400-001-0.0
Metal Open Rail Gate

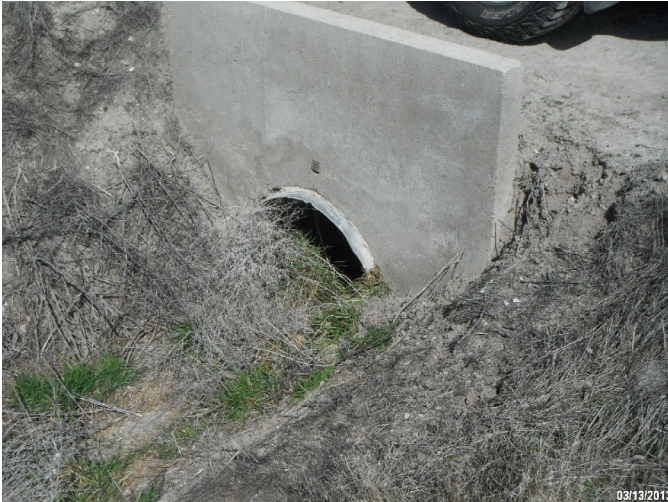
Photo: HANF_C4_0185 Route: 400-001-0.33
Metal Culvert 14ft long 24in dia. 2ft deep

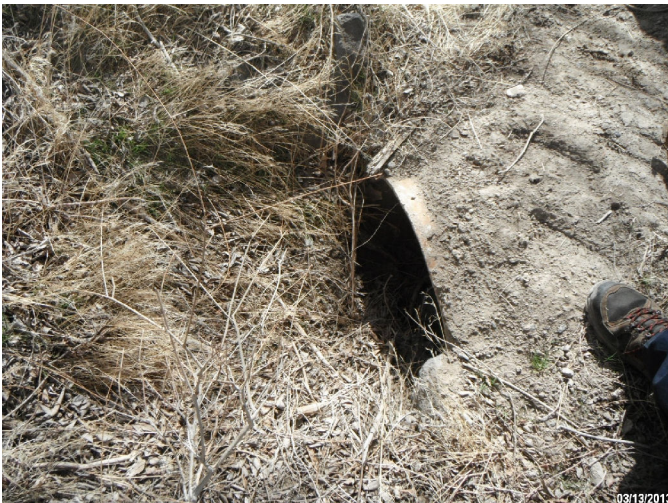
Photo: HANF_C4_0187 Route: 400-001-0.39
Metal Culvert 20ft long 24in dia. 1ft deep

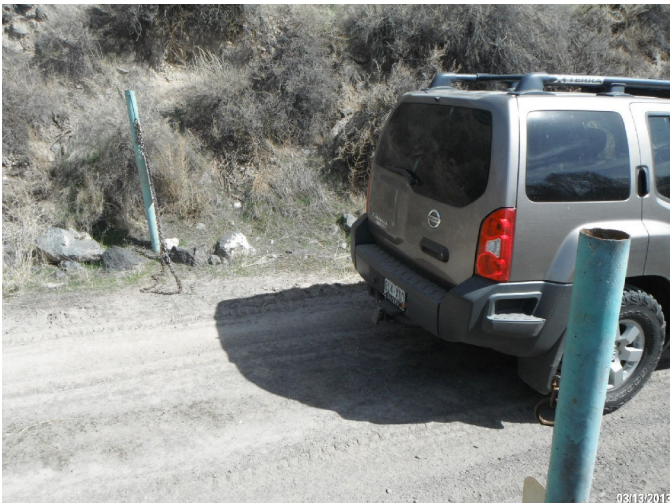
Photo: HANF_C4_0193 Route: 400-001-0.51
Metal Cable Gate

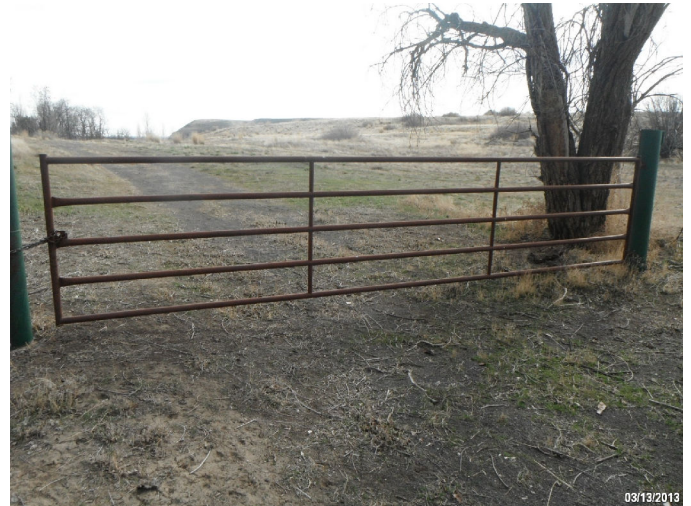
Photo: HANF_C4_0208 Route: 403-001-0.18
Metal Open Rail Gate

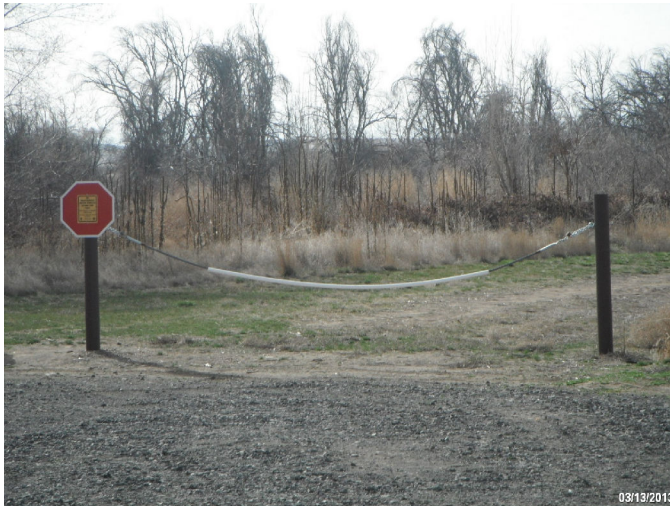
Photo: HANF_C4_0223 Route: 904
Metal Cable Gate
